**INDIANAPOLIS POWER & LIGHT COMPANY**

**REPORT IN RESPONSE TO**

**DOWNTOWN UNDERGROUND NETWORK**

**FOR THE YEAR ENDED 2012**

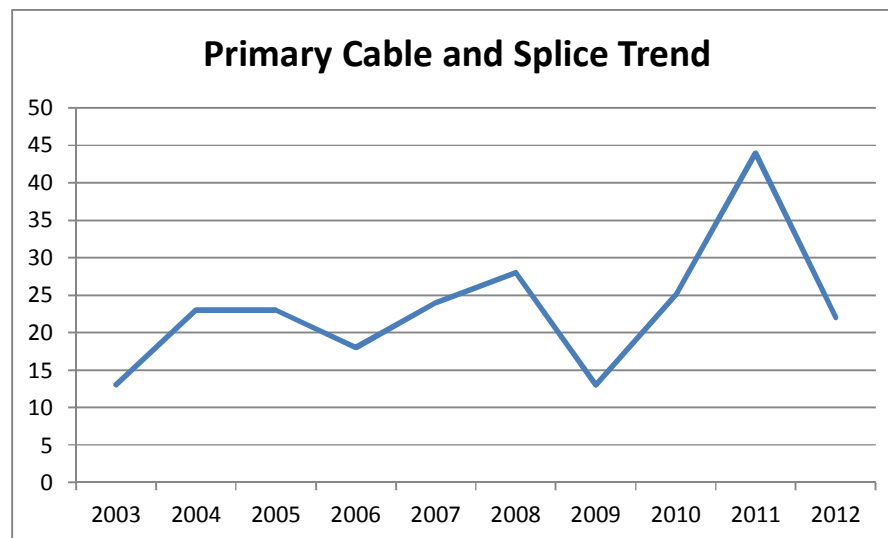
Figure 3-2 Primary cable and splice failure trend

**Less cable and splice failures** - The number of primary cable and splice failures dropped significantly in 2012 when compared to 2011. This improvement is especially noteworthy considering the greater stress from the 2012 heat wave. Figure 3-2 shows the ten year trend only for primary cable and splice failures.

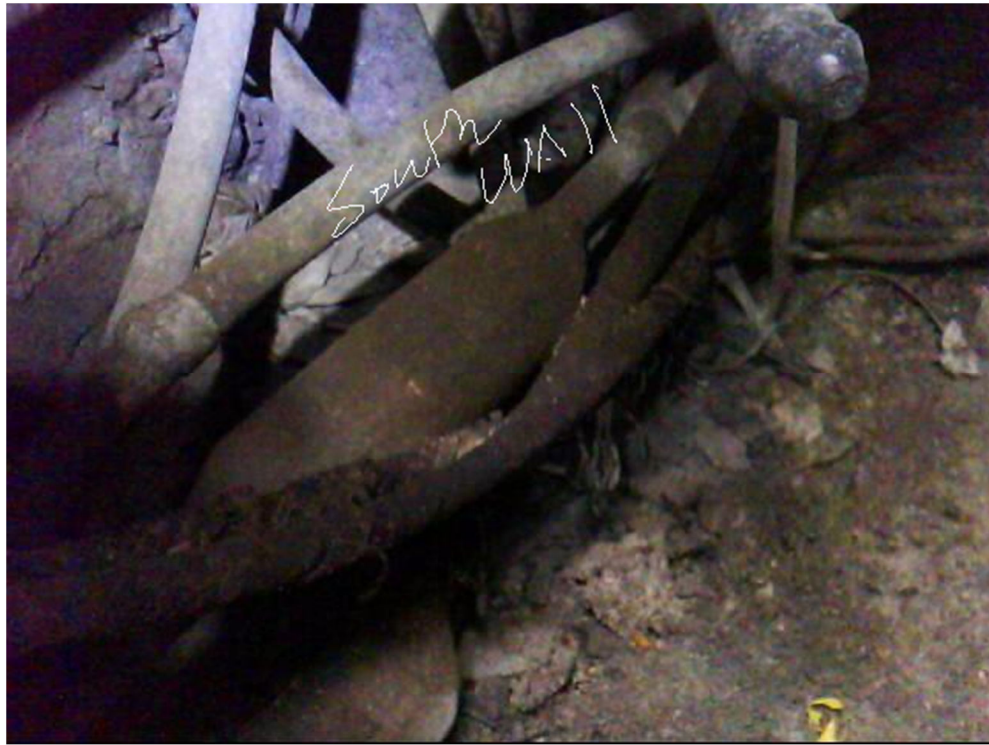
Figure 3-5 Handheld tablet picture with technician note on picture

Question	Response	Repaired	Photo	Notes
Check Manhole - Cover	Normal - Solid			
Check Manhole - Ring	Normal			
Check Manhole - Steam	Normal - No steam issues			
Check Manhole - Flooding	Normal condition - dry			
Check Manhole - Debris	Normal condition			
Check Primary Cable	Normal			
Check Primary Cable - Splice Cases	Normal - No leaking			
Check Secondary Cable	Normal			
Check Secondary Splices	Damaged or oil seeping	No	<a href="#">View</a>	north wall old leak need to replace wyes with straights....south wall old leak wye splices
Check Secondary Splices	Damaged or oil seeping	No	<a href="#">View</a>	north wall old leak need to replace wyes with straights....south wall old leak wye splices
Check Secondary Current	Normal			
Check Ground or Neutral Cables	Normal - No problems found			
Check Manhole - Cable Racks	Normal Condition			
Check Manhole - Cable Support	Normal - Adequate			
Check Asbestos	No			
Check Primary Cable - ID Tags	Missing or unable to read	Yes	<a href="#">View</a>	d6 east ug 451 just need an additional tag added off the wye splice

The photograph of the problem is Figure 3-5. Also notice the technician wrote a small note on the figure adding information about the location of the problem. The technician wrote the note using the tablet computer.

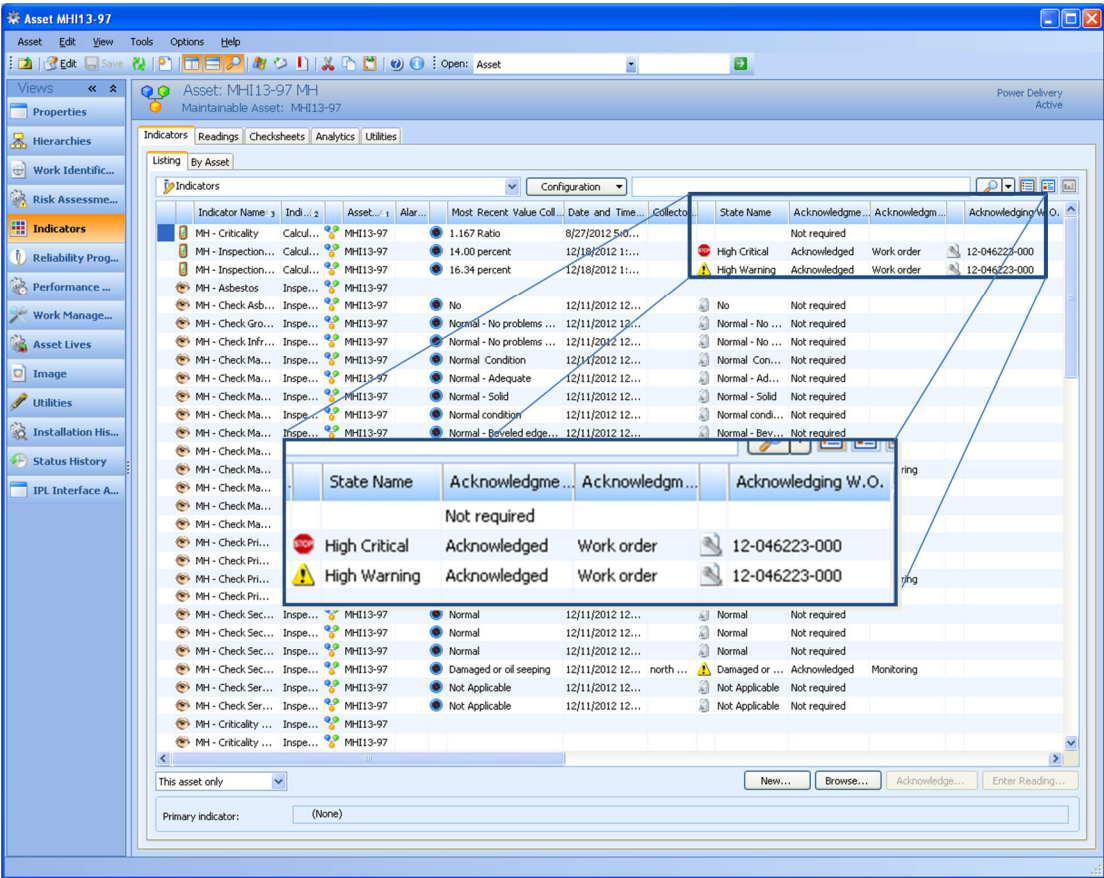
Figure 3-6 Acknowledged alarm and work order reference in Ivara

Tablet computer data uploads to Ivara. Ivara follows IPL business rules for condition and impact of the reported problem. Business rules in Ivara calculated a condition indicator and issued an alarm for manhole MNI13-97. Figure 3-6 shows the Ivara indicator screen with an important portion of the screen expanded for easier reading. An IPL employee acknowledged the alarm and issued EMPAC Work order 12-046223-000 to make repairs.

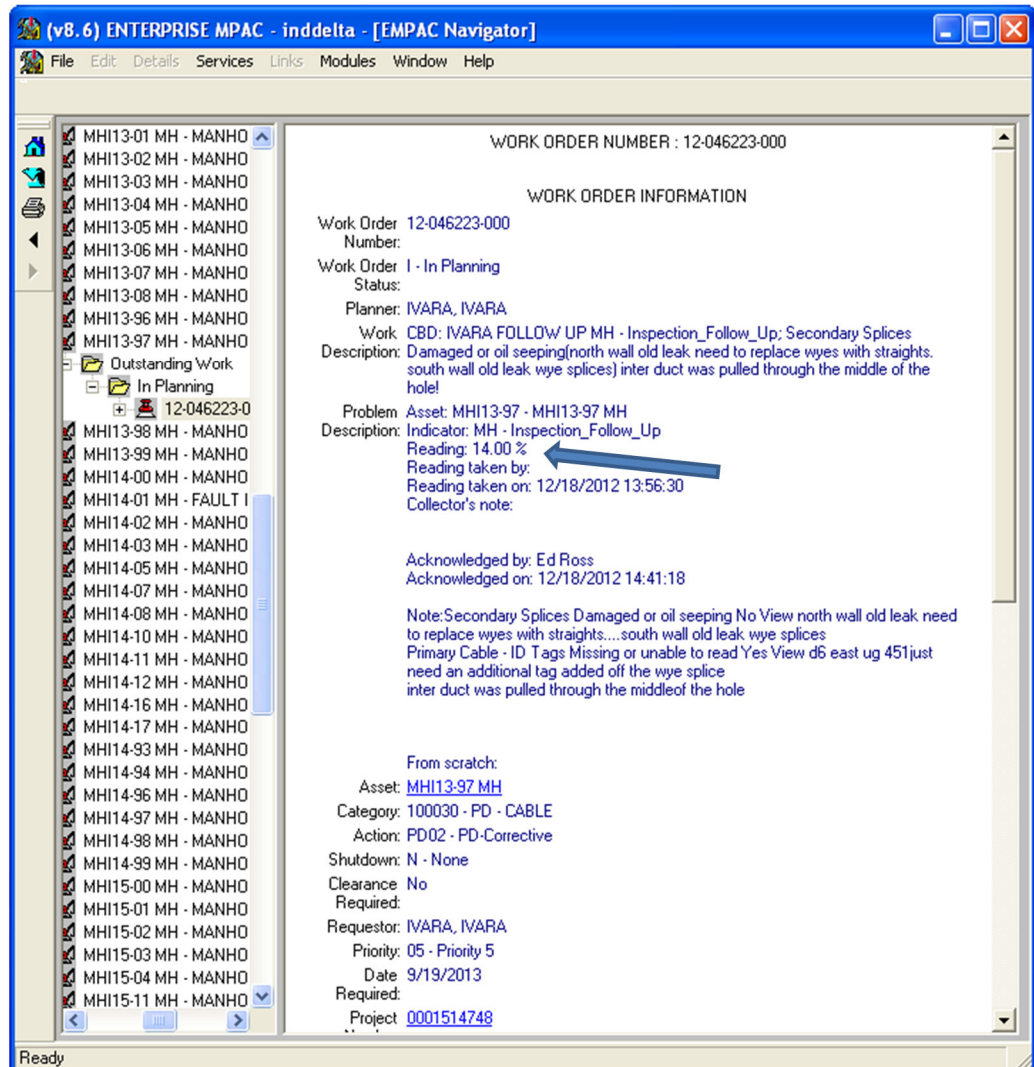
Figure 3-7 Work order as it appears in work management with indicator

Here is work order 10-046223-000 in the EMPAC asset and work management system. Note the arrow pointing to 14.00% importance reading from Ivvara carried through to EMPAC. Additional details of the work needed carry through to the description. This gives the scheduler guidance on the priority of the work. The 14.00% reading generated a priority 5 rating based on IPL business practices.

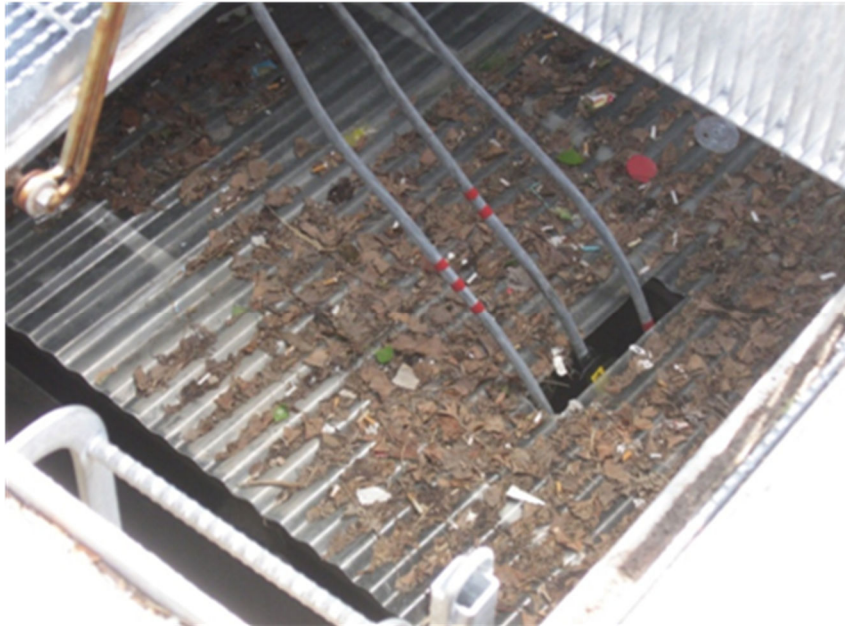
Figure 3-8 Debris captured by Deflector Shield

**Alternate plan developed for pressurization** - IPL has encountered a number of issues in trying to pressure test network protectors, with a focus on those identified as having aluminum bus. Even after replacing the door gasket material the network protectors still will not hold pressure. IPL has discussed this issue with O'Neill Consulting and the new course of action is to install deflector shields above these units. IPL is also investigating installing a moisture sensor either in the vault or in the network protector to detect a potential moisture problem and allow time for corrective action to be taken. Figure 3-8 shows an example of the deflector shield. A total of 25 shields were installed for this particular reason.

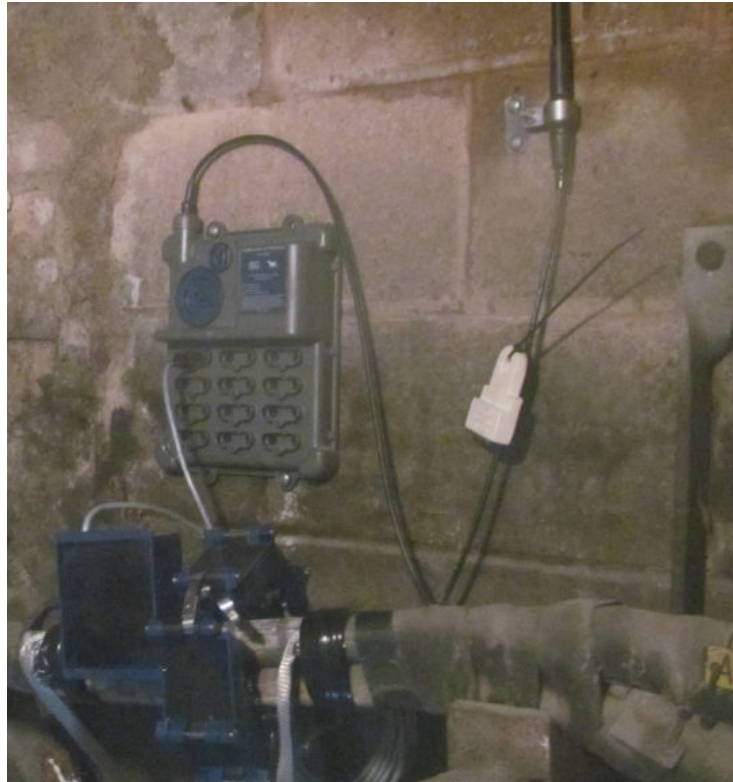
Figure 4-7 Cable fault indicator

**Fault indicators** - Installation of the fault indicators was not completed prior to the end of 2012. This work was rescheduled to coordinate with other Smart Grid work that will be completed by the end of April 2013. Scheduling the needed network primary circuit outages to install the fault indicators was also a factor in delaying the final installations. Fault indicators are now installed on 43 of 44 circuits. Fault indicators will be installed on the 44<sup>th</sup> circuit when the cable is replaced. Cable replacement on this 44<sup>th</sup> circuit is part of IPL's practice cable replacement program and is already in progress. Figure 4-7 shows a fault indicator installed in a vault.

IPL has seen benefits from the primary cable fault indicator. The indicators have been used to quickly narrow down the section of the circuit the fault is located in, greatly reducing the amount of time test voltage is applied to the circuit to find the fault. In one instance the fault was located in less than 45 minutes, where without the fault indicator information it could take upwards of 6-8 hours to find a fault. In another case the circuit faulted and did not yet have fault indicators installed. The crew could not locate the fault. The fault indicators were installed and the substation breaker was closed. It immediately tripped out but the fault indicators tripped narrowing down the section of the circuit where the fault was located. This helped the crew to find the fault much faster than they otherwise would have.

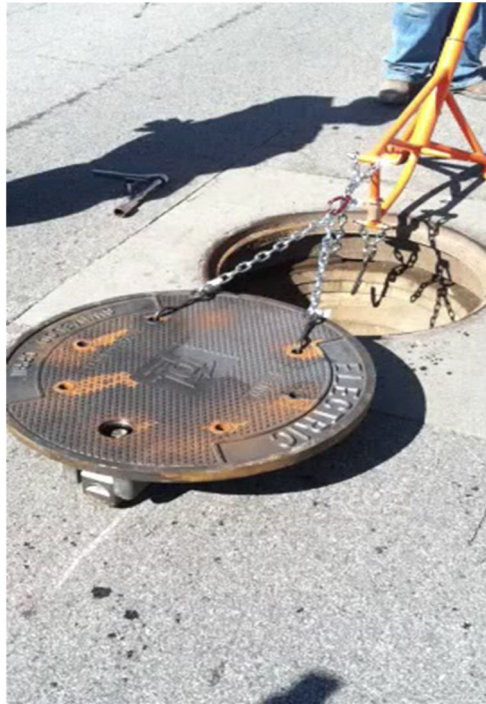
Figure 4-8 SWIVELOC™ manhole cover installation

**Swiveloc™ locking manhole covers** - IPL installed 152 of the Swiveloc™ locking manhole covers prior to the Super Bowl in February 2012. Another 50 Swiveloc™ manhole covers were installed in the fall of 2012 in high pedestrian traffic areas in the downtown area. Figure 4-8 shows a picture of a Swiveloc™ installation. To date IPL is not aware of a cable fault in a manhole with a Swiveloc™ cover. In the spring of 2013, a sampling of Swiveloc™ covers will be inspected for signs of corrosion from road salts. Assuming no corrosion issues or other problems are encountered in removing the covers after they have been exposed to the elements for a year, installation of additional Swiveloc™ covers in selected locations is planned.
